Reducción del riesgo de desastres

Project: Construction of a sewage system and wastewater treatment plant for the Guaqui town

General project data

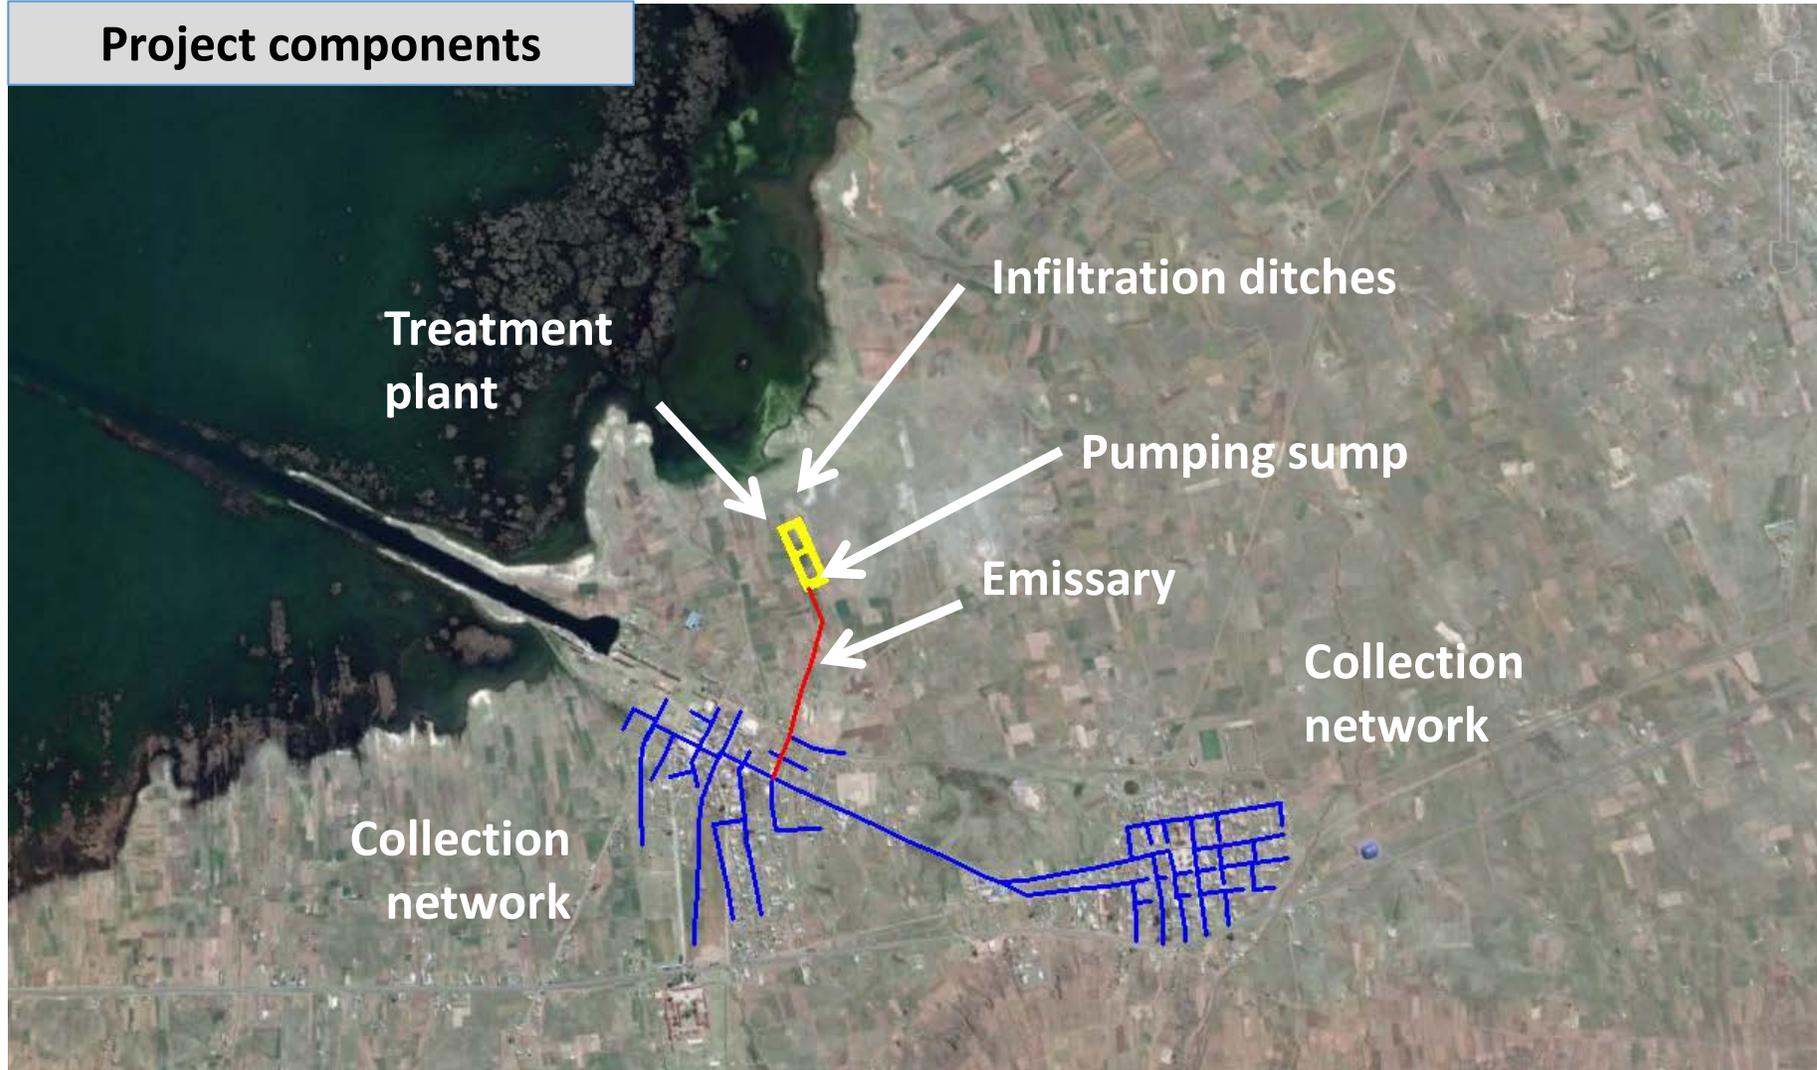
Project components

Current situation: The final study design was prepared by the company Pirámide Ingeniería y Construcciones SRL and is in the contracting stage for its execution.

- Collection network
- Emissary
- Pumping sump
- Treatment plant
- Infiltration ditches

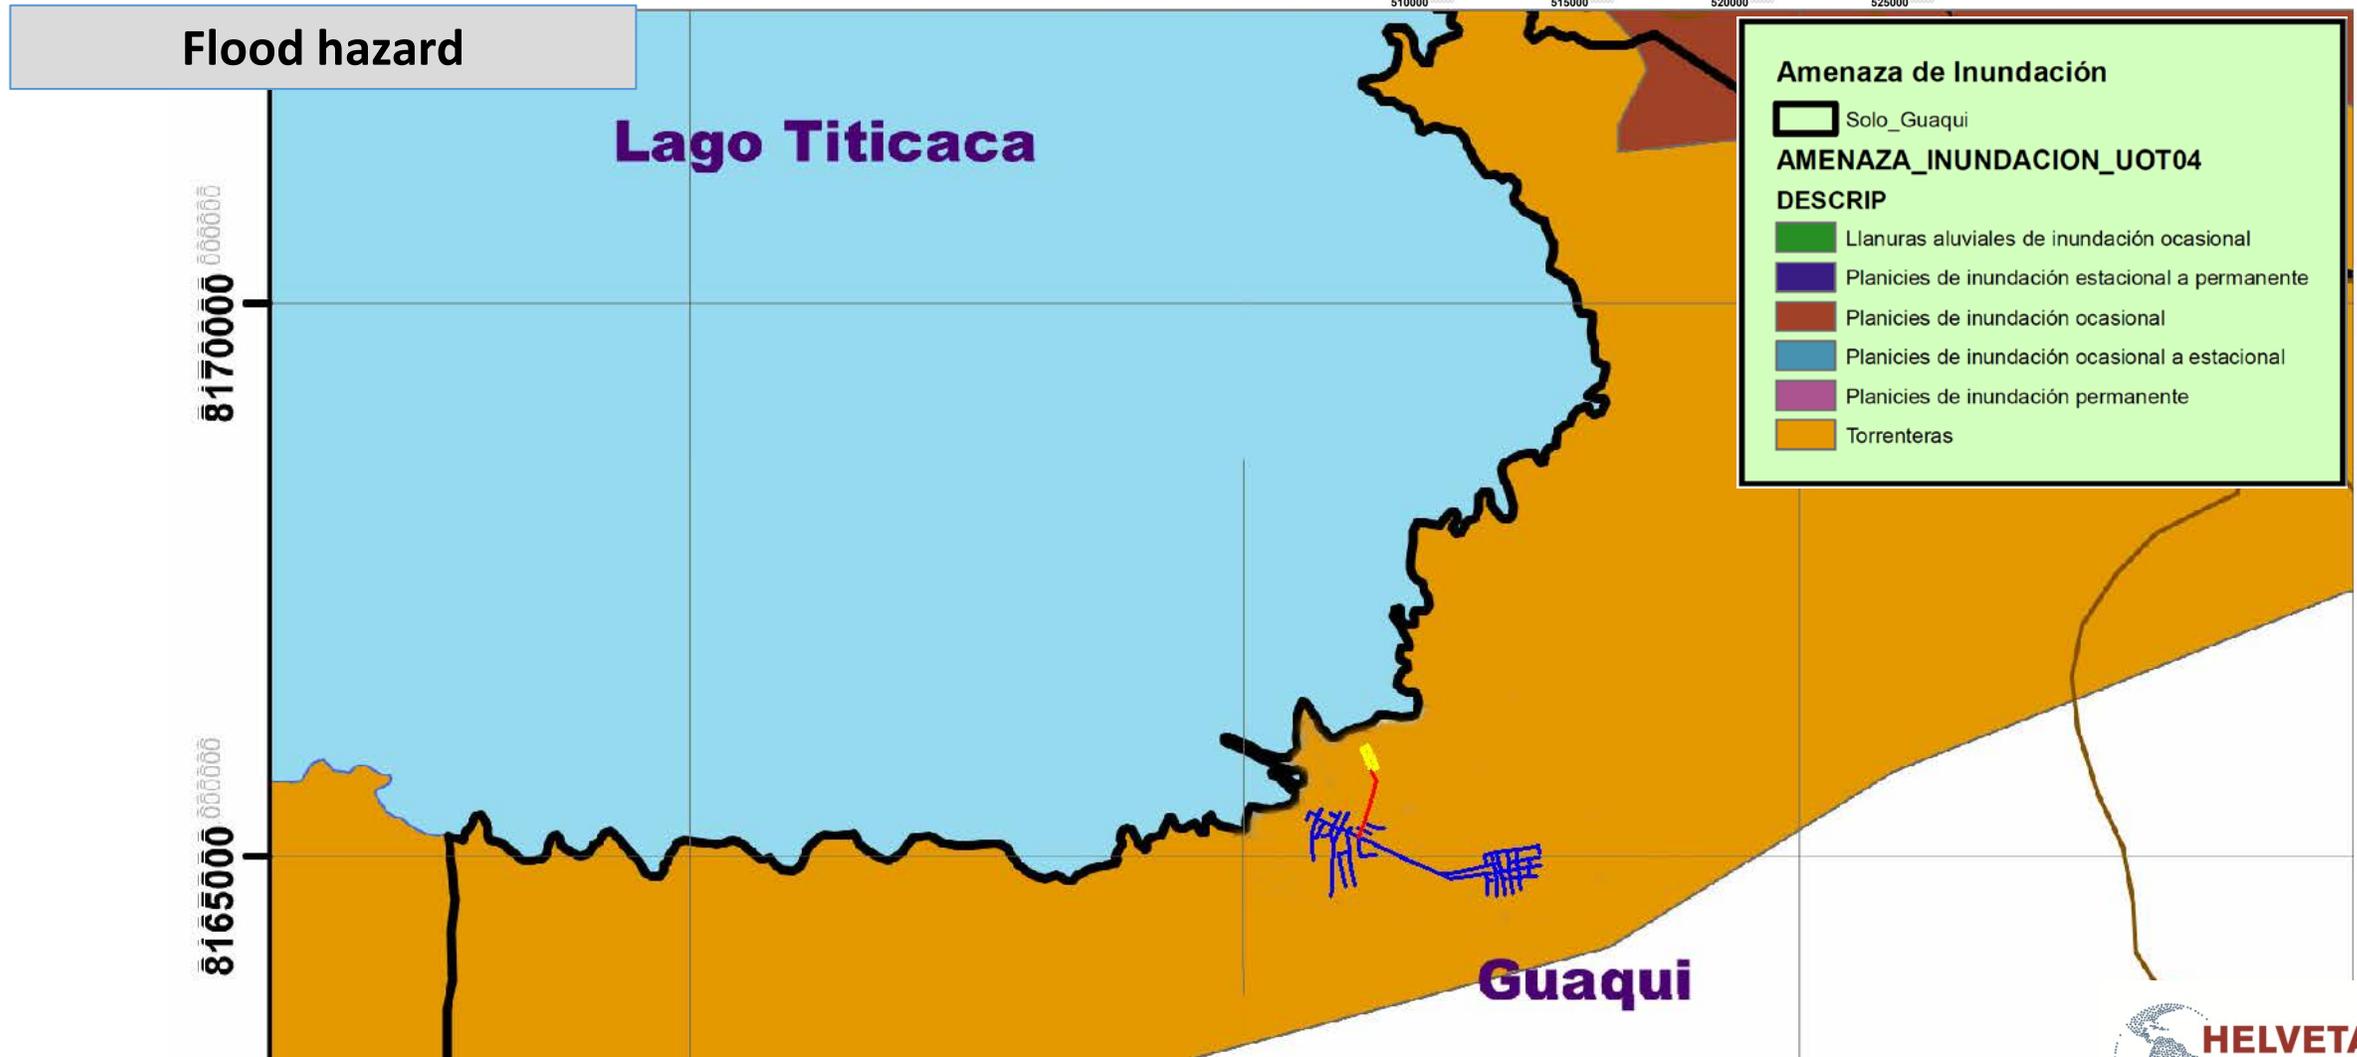
Components and flood hazards

- Floods due to the increase of the Titicaca Lake water levels
- Occurrence of frost with a tendency to increase in the future

- Does not have a Risk Management Unit
- Damage to pumping sump equipment
- Flooding of the sand trap
- Collapse of oxidation lagoons
- Efficiency reduction of stabilization lagoons due to periods with low temperatures

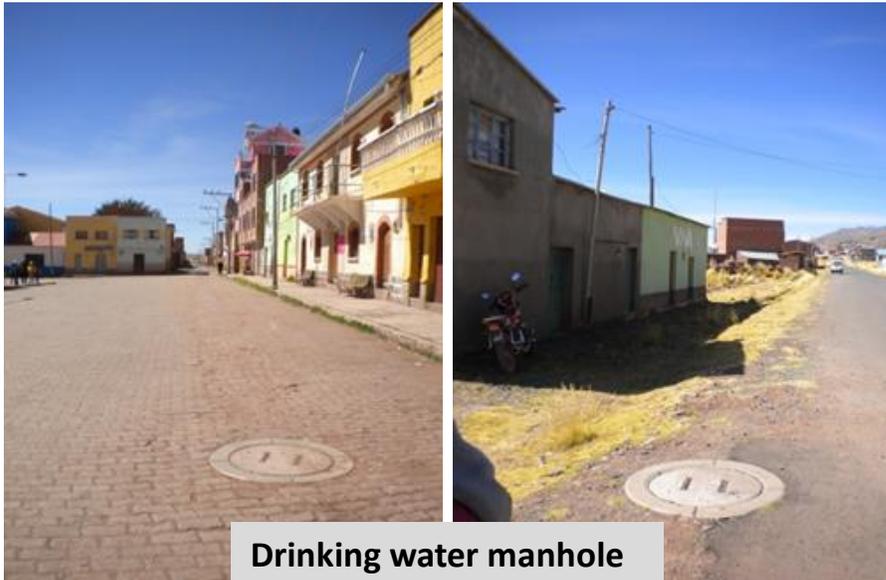
Drinking water manhole

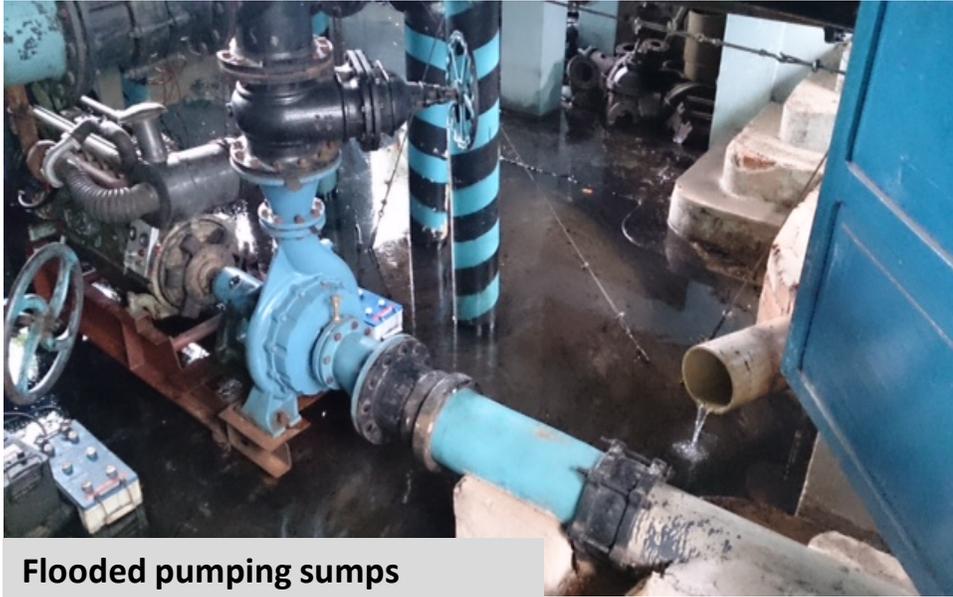
Flooded pumping sumps

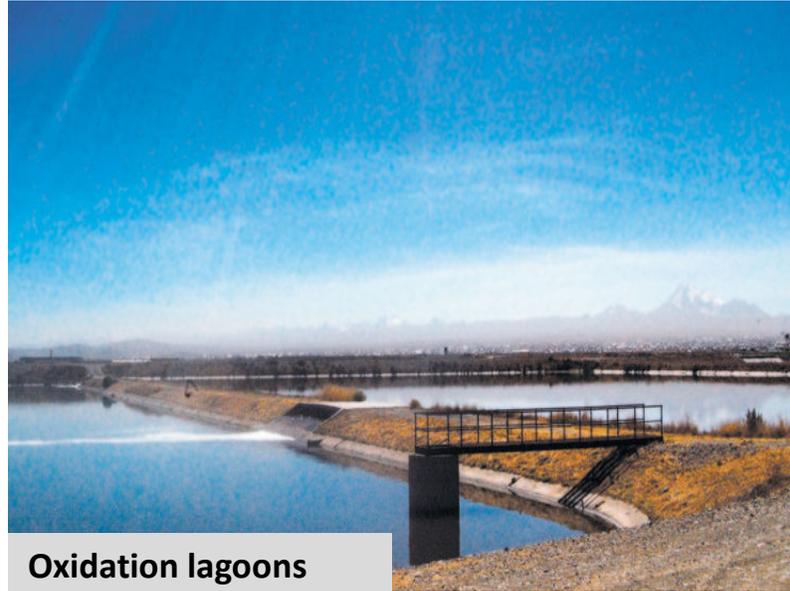
Oxidation lagoons

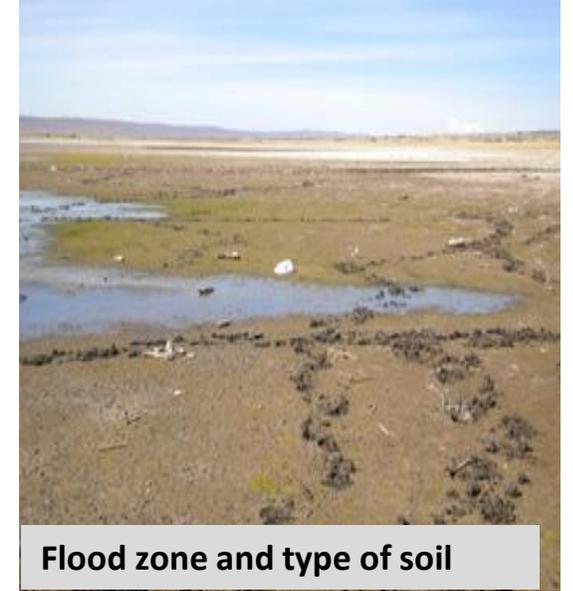
Flood zone and type of soil

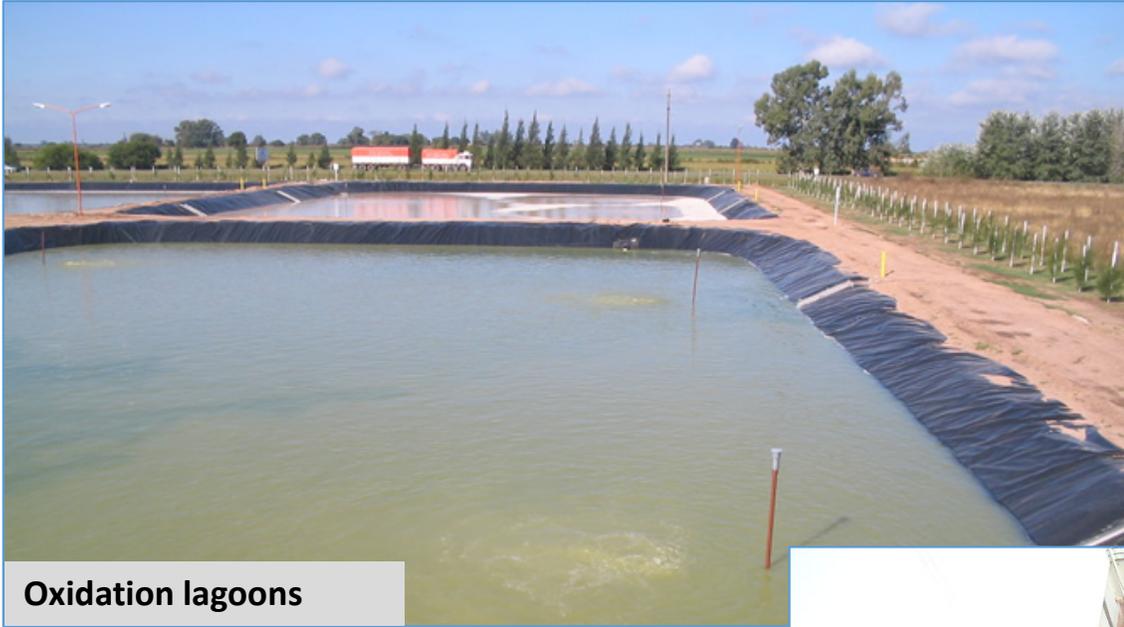
Oxidation lagoons

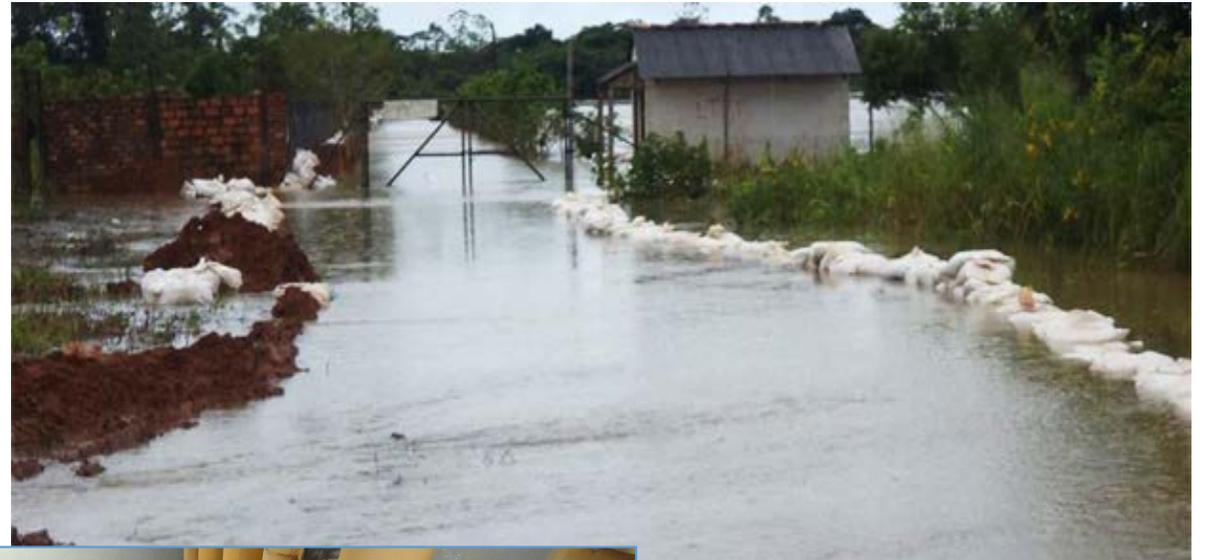
Flooded oxidation lagoons

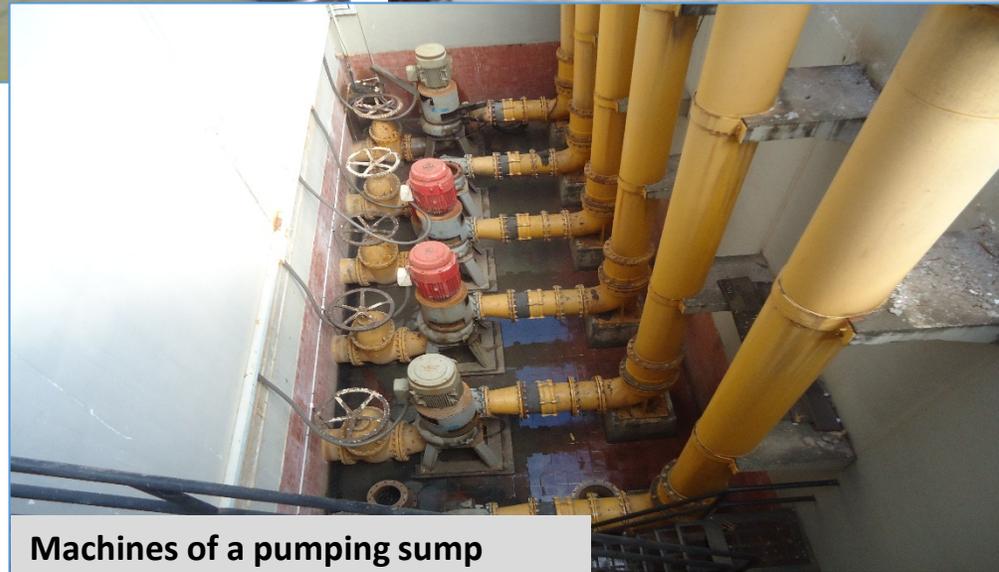
Machines of a pumping sump
